Article Number - 00011-2010

Article applies to – AIT250, AIT1000 and CLB1000 AIS Transponders

## **ISSUE: Fault Finding Class B Transponders**

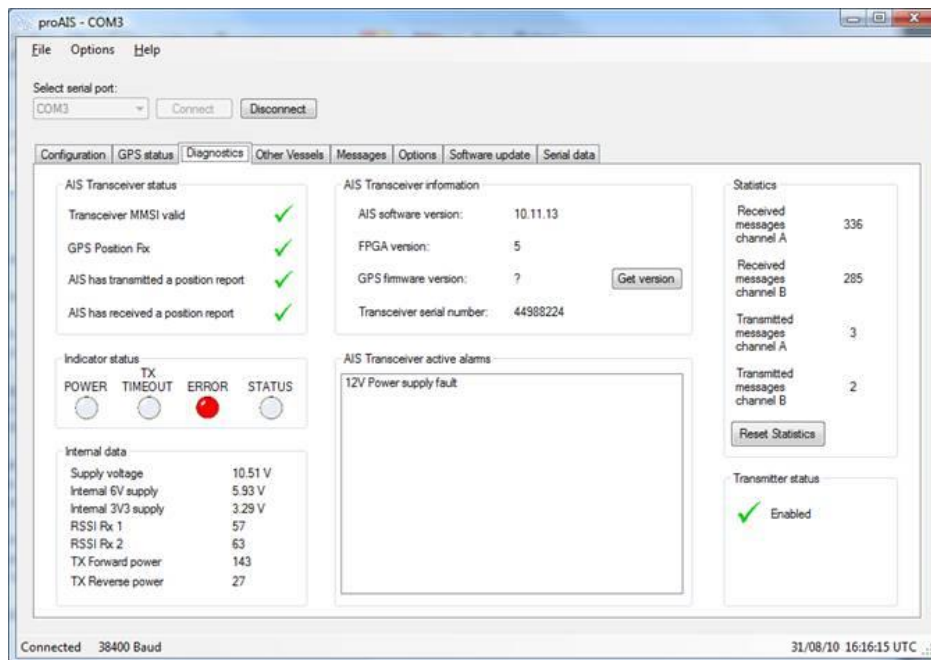
Even if the power connections are OK and the transponder is powering up, it is possible that the supply voltage is low – particularly after a long passage in a sail boat. The Low Voltage Alarm is triggered at around 10.6v – see screen shot below. Note the “12v Power Supply Fault” is a warning rather than a critical alarm.

You will note in the bottom right panel that various internal voltages are measured and displayed by the proAIS software. The key voltage, the one that you have control over, is the Supply voltage. A problem on any of the internal voltages means that the transponder has a fault and a factory repair is necessary. However, a Supply Voltage problem is usually due to; poor wiring, large voltage drops in the system or low batteries.

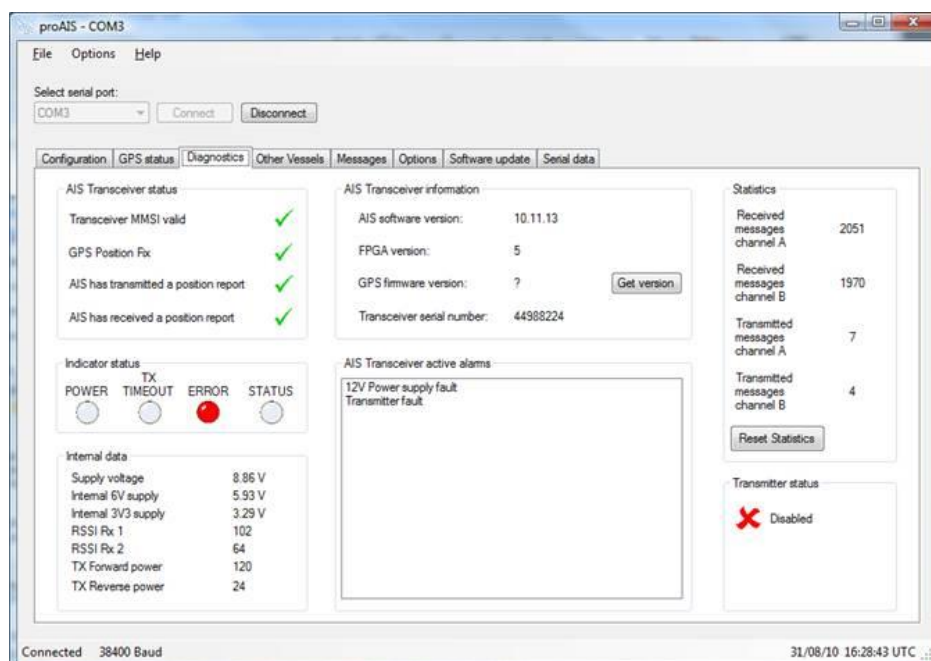
Even in the fault/alarm condition above, the transponder still continues to work and will not stop transmitting until the supply voltage gets down to around 9.3v. Then transmission will stop and you will see the following screen in proAIS. Note the Transmitter is shown as “Disabled” in the lower right pane and the “Transmitter Fault” Alarm has been triggered.

As soon as the supply voltage increases again, transmission will recommence. It is possible that operation of other high current devices on the boat (such as an anchor winch, inverter, starter motor, etc.) could cause the supply voltage to momentarily go low, which would trigger an alarm but the AIT1000 should recover and start re-transmitting within 30secs of the fault condition. During the 30secs the Red and/or Yellow light will be lit.

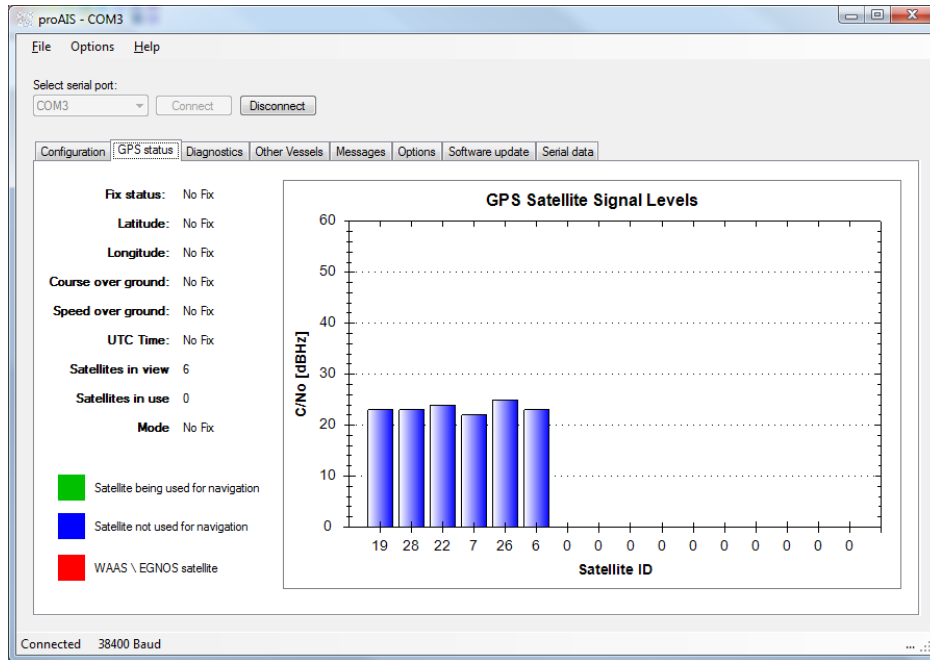
The most common cause of the transponder not transmitting its position (Yellow LED continuously on), is no GPS fix but it can be caused by other faults. To check the GPS reception, click on the “GPS Status” tab.

All of the GPS signals should be >25 and will be green in colour if good enough for navigation. The image above was actually taken with no antenna connected.

If the GPS signals are low or non-existent, a simple voltage reading can be taken at either end of the GPS antenna cable to see if the 5v supply voltage to the antenna is present. The following process should be followed;

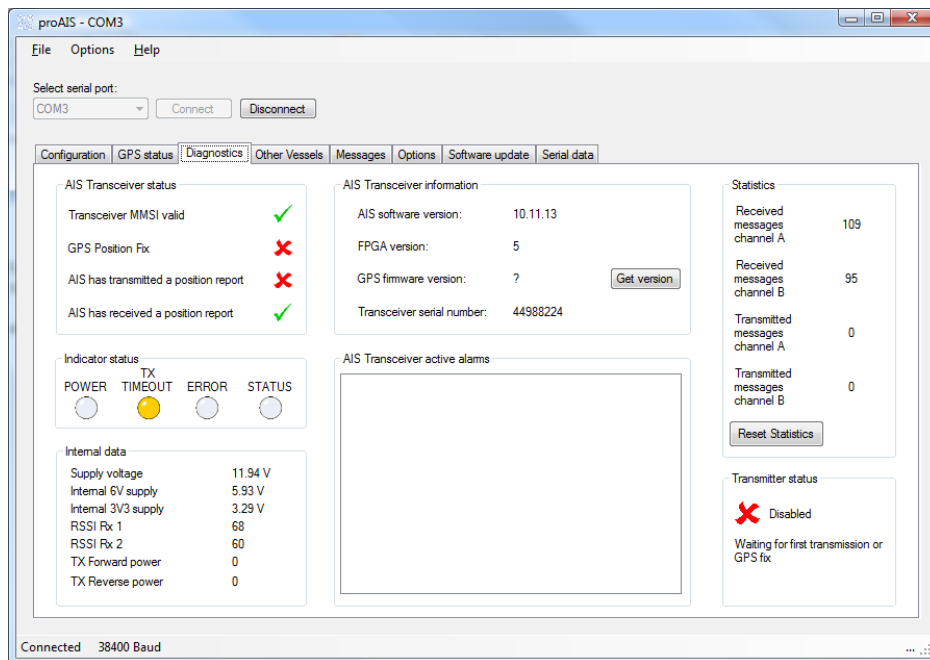
Returning to the "Diagnostics" Tab of proAIS again, see image below, pay particular attention to the Receiver Signal Strength Indicators (RSSI) of the dual channel receiver and the Forward and Reverse Power of the transmitter, bottom left hand corner.

The RSSI (Received Signal Strength Indicator) and TX Power values are good indicators of how well your antenna is receiving and sending data.

- RRSI values should be between 20 and 100 - if they are continually lower than this there may be a problem with the antenna or transponder
- TX Forward Power should be as high as possible, typically between 130-150
- TX Reverse Power should be as low as possible, typically between 10-30

A VHF antenna failure may cause all AIS reception and transmission to stop or it may just give poor reception and transmission range. Either way, if the forward and reverse power values and the RRSI readings are outside of the normal ranges, this could indicate an antenna problem which needs to be fixed to avoid ongoing damage to the transponder.

After a close visual inspection of all joints and connections in the VHF cable, the best way to prove if the antenna is at fault is to temporarily swap it for a known good antenna. The VHF antenna connection on the transponder is a BNC connector and it may be necessary to fit a BNC to TNC or BNC to PL259 (VHF) adaptor in order to connect another VHF antenna.
