Article Number - 00029-2012

Date - 2nd Feb 2012

Article applies to - WL50 (MK2) and WL400 Wifi Adaptor

ISSUE: Installing a WL50 (MK2) or WL400 on Mac OS X 10.7 (Lion)

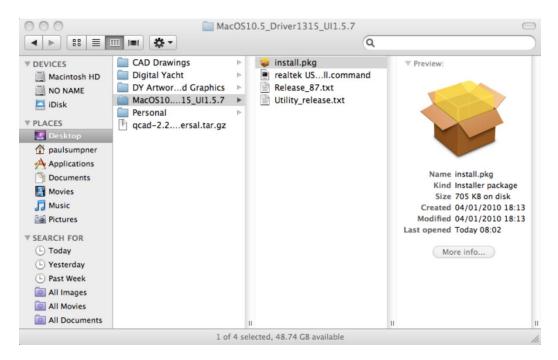
During the installation process you will see the window shown below which pops up to say that the driver file has not installed properly. Press OK and the installer will finish successfully and you must then restart the computer.

System extension cannot be used
The system extension "/System/Library/Extensions/ RTL8187I.kext" was installed improperly and cannot be used. Please try reinstalling it, or contact the product's vendor for an update.

These drivers actually work perfectly on OS X 10.6, but the installer sets the wrong owner/permissions for the RTL8187I.kext file (driver) and it is necessary to follow the step by step guide below;

- 1) Locate the incorrectly installed file RTL8187L.kext file which should be found in the "/System/Library/Extensions" folder and place it in the Trash
- Run the application "Kext Helper b7", which is on the Digital Yacht Software CD, then click and drag the RTL8187L.kext file (on the CD) into the white box on the Kext Helper window
