Article Number - 00043-2012

Article applies to - AIT2000, CLB2000 and AIS200N2Net

ISSUE: Updating the firmware of an AIT2000, CLB2000 or AIS200N2Net

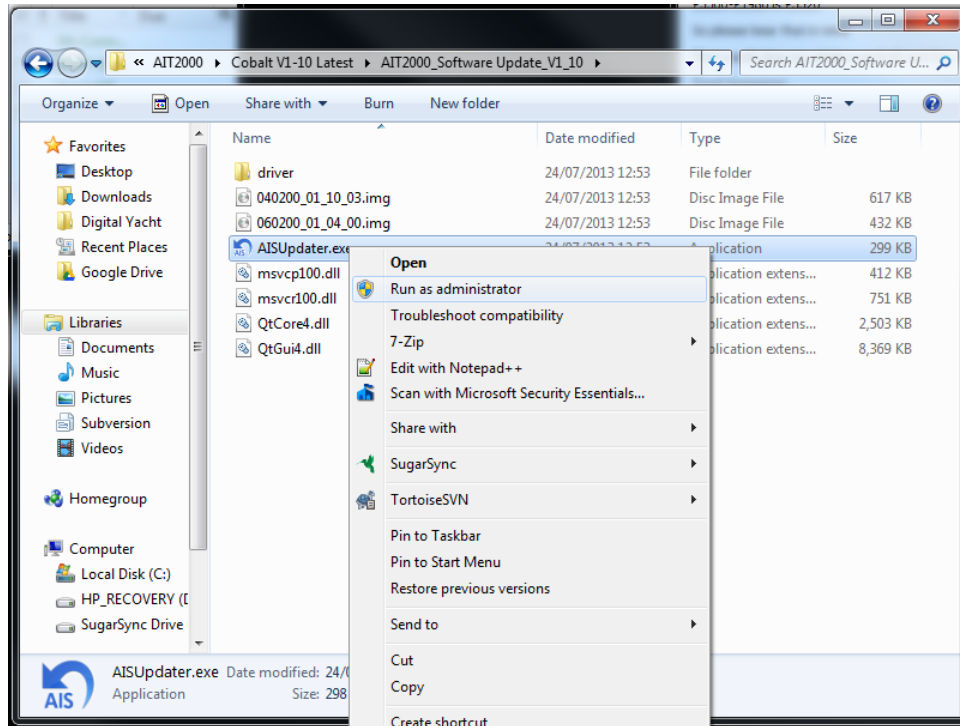
Figure 1

Extract all of the files in the “AIT2000_Software_Update_V1-10.zip” file in to a new folder and then open that folder and you will see a screen similar to the one in Fig 1 below.

If you are running Windows XP, double click on the file “AISUpdater.exe” as shown highlighted in Fig 1. If you are running Windows Vista/7/8 on your PC, then right click on the same file and select “Run as administrator” from the menu. This will ensure that the User Access Control (UAC) introduced with Windows Vista will allow the program to install correctly. You should now see the screen shown in Fig 2 which will guide you through the update process.

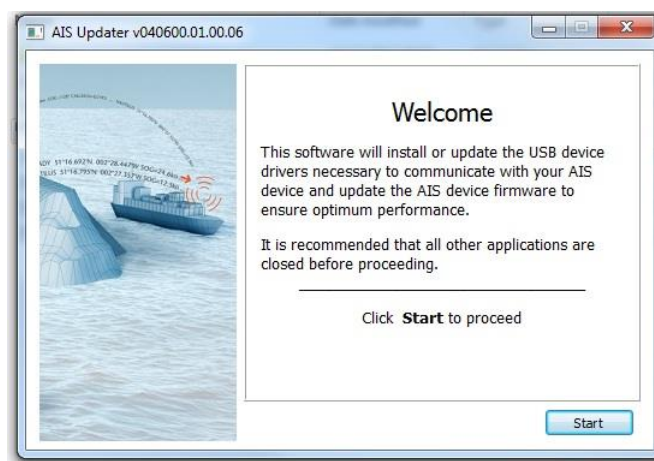
Figure 2

Read the directions and then select “Start” when you are ready to begin the process. The first stage is to update the USB drivers on the PC and the second stage is to update the software on the connected device. The software updater automatically recognises which device is connected (Class B or Receiver) and selects the appropriate device software update for you.

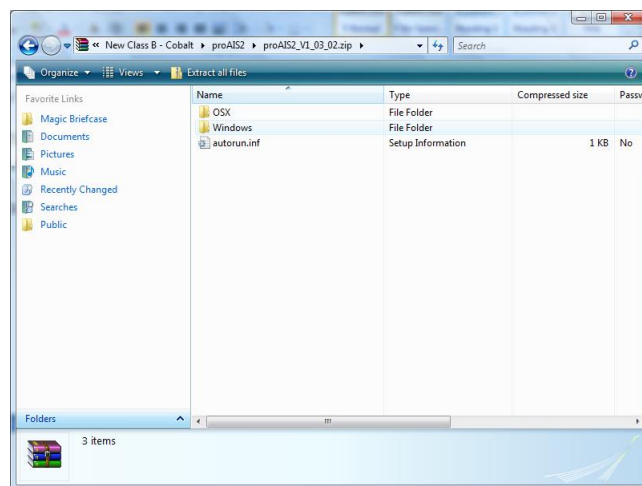
Figure 3

If you wish to install the new version of proAIS2, double click on the “ProAIS2_V1_03_02.zip” file that you downloaded and you will see a screen similar to the one in Fig 3.

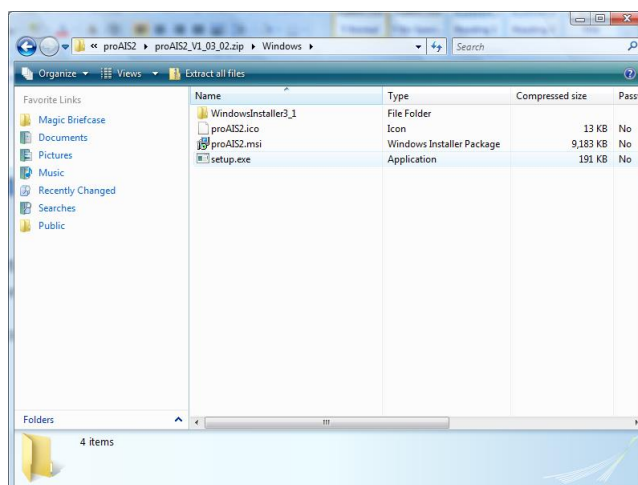
Figure 4

Now double click on the “Windows” folder and you will see a screen similar to the one in Fig 4.

Again, if you are running Windows XP, double click the “Setup.exe” file or if you are running Vista/7/8 right click on the file and select “Run as Administrator” to start the proAIS2 installation.

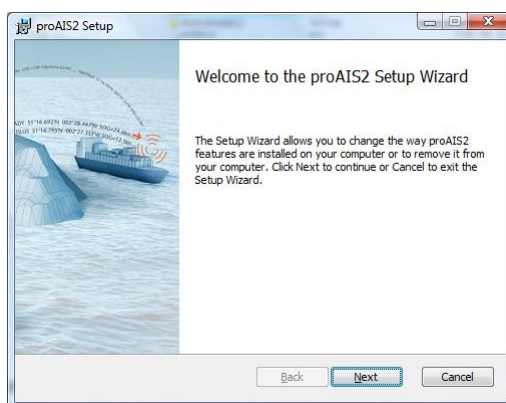
Figure 5

The proAIS2 installation will now start and you will see the window shown in Fig 5.

Click the “Next” button and then follow the on screen instructions until the installation is completed.
